Manhole Inspection Summary

Manhole # S51I__008MH

Insp Date: **4/2/08 2:39 PM**

Location Address: **500 Streeper St**

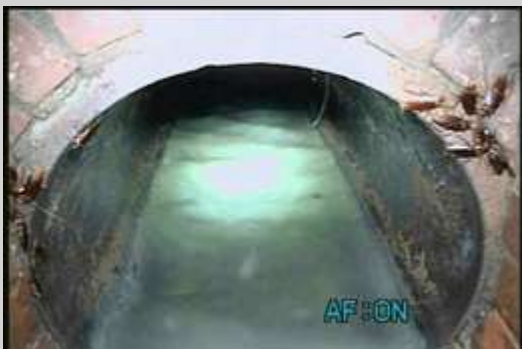
3 O'Clock Inflow

15 in. Circular Gravity Sewer
Pipe In @ 3 O'Clock

Pipe Height: 0 (in.) Direct

Pipe Material: **Clay** ☐ Pipe Lined

Invert Depth: 11.60 (ft.) Flow Characteristics: **Fast**

Deposits: ☒ None ☐ Mud ☐ Sludge ☐ Debris ☐ Grease

Infiltration: **None** Pipe Seal Cond: **Unknown**

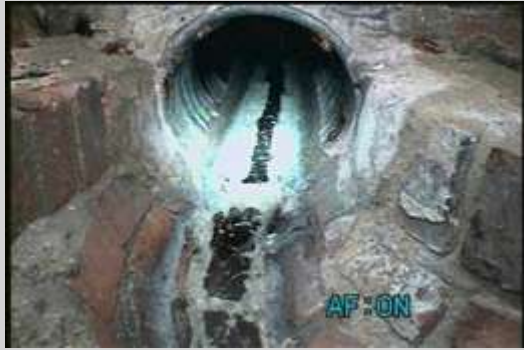
9 O'Clock Inflow

15 in. Circular Gravity Sewer

Pipe In @ 9 O'Clock

Pipe Height: **0** (in.) Direct

Pipe Material: **Clay** ☐ Pipe Lined

Infiltration: **None** Pipe Seal Cond: **Unknown**
